Haul road stabilisation

Haul Road 'A'

Jellinbah Coal Haul Road Stabilisation

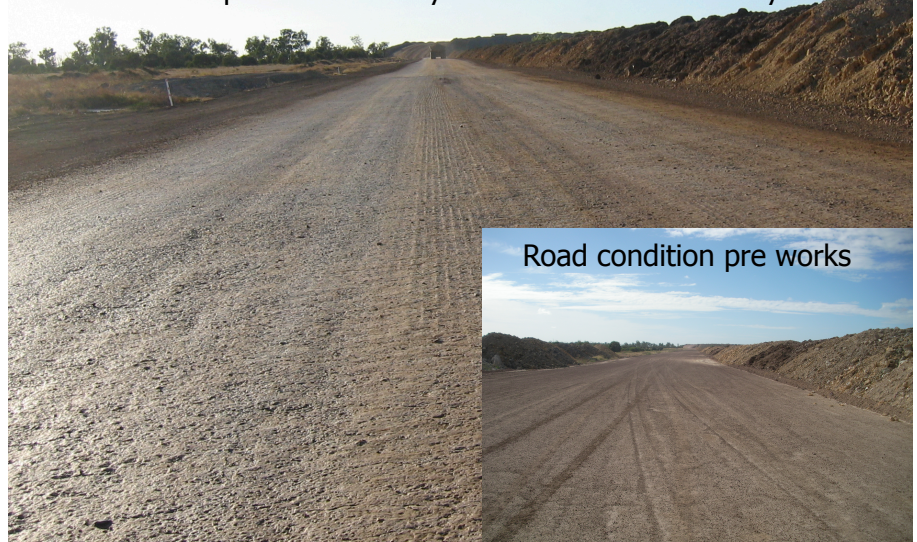
Jellinbah Coal Mine is situated west of Bluff, Qld. Haul road 'A' is constructed of mine spoil (mainly tertiary clays). Road structure was unstable in several areas requiring constant maintenance and watering for dust control. The running course was undulating and softened to depth during rain events.

Road condition pre works

Deep compaction techniques were applied initially to strengthen the roads lower levels. After compaction the running course was stabilised (100mm) using PolyCom stabilising aid.

Validation of improved road conditions after work -
Dynamic modulus of the road was improved from 38.8 to 69.
Rolling resistance was reduced by 15%
Translated to effective fuel savings and CO2 emissions of 5%
