Sub-grade improvement (Gas Plant and R.O. Plant construction)

Talinga, Qld

Project Facts

Origin Gas Plant Construction

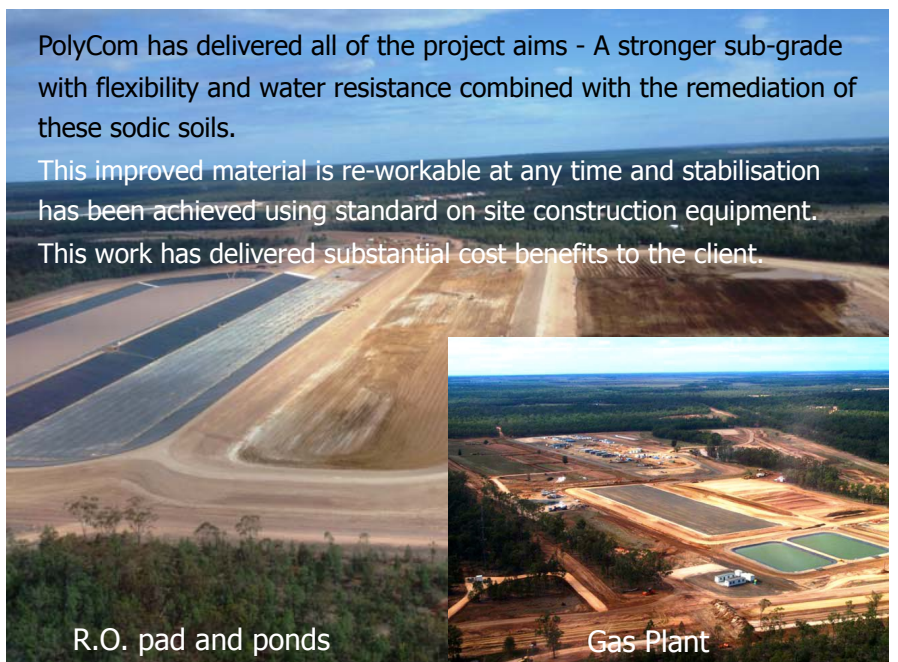
R.O. pad and ponds

Gas Plant
