Project Facts

Sub-grade stabilisation

Sub-grade Stabilisation
Road re-build

Boundary St
Toowoomba, Qld

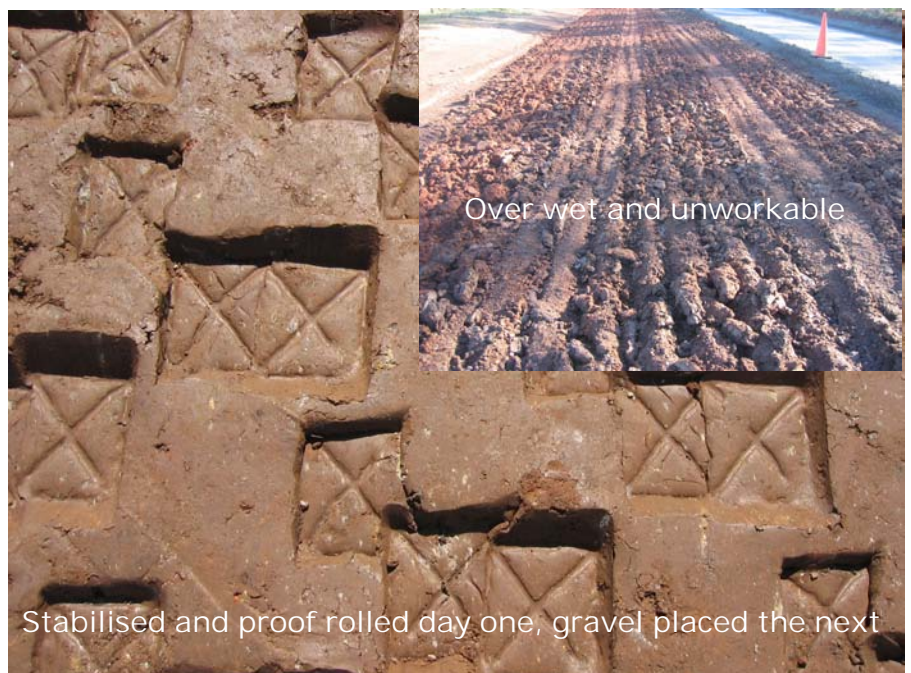
Boundary Road East reconstruction required removal and replacement of in-situ sub-grade material or stabilisation. The over wet ground had been worked by council for several days in an attempt to dry the area to a workable state. Continued wet weather was hampering and prolonging this work.

SEALS Group was engaged by shire management to stabilise the in-situ sub-grade with PolyCom stabilising aid to enable a more useful and workable base for the road reconstruction. PolyCom was chosen because of councils past experiences with the product - typically delivering increased workability and improvements to CBR and compaction rates in low strength and variable ground. Increasing the strength and water resistance of sub-grades ensures a longer lasting pavement - a major project benefit. The area was stabilised in the morning with proof rolling being completed the same afternoon. Gravel was placed the next day.
