Failed road pavement repair - Insitu stabilisation with PolyCom Stabilising Aid

Project Description:
Insitu Patch Repair -
Stabilisation

Location:
Kin Kin
Sunshine Coast QLD

Date:
January 2017

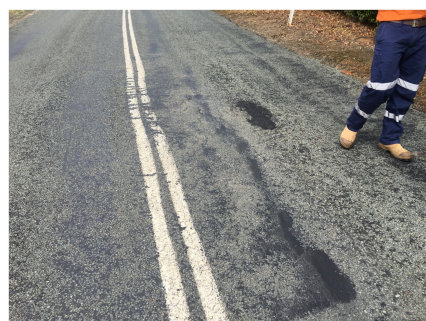
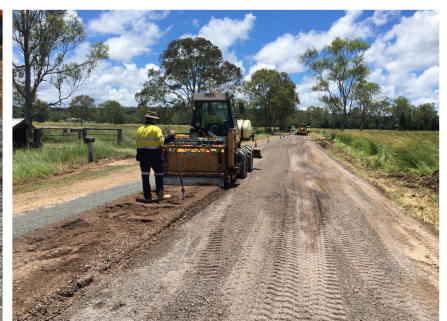
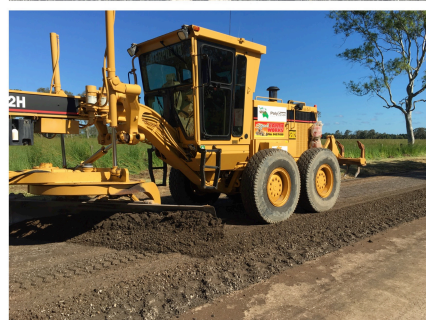
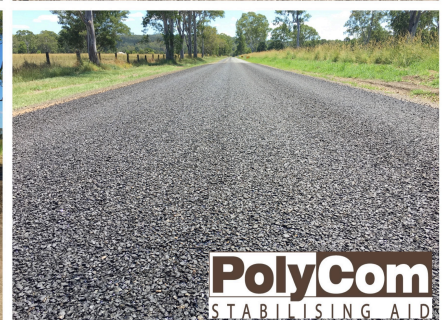
The project involved importing a minimal amount of road base as a corrective layer, pulverising the seal and incorporating it with the insitu material at a depth of 200mm. The material was then stabilised with PolyCom Stabilising Aid, compacted and re-sealed.

The utilisation of PolyCom Stabilising Aid delivered a stronger, more dense and water resistant flexible pavement.
